**BEYER : BUYER**  
**HOME INSPECTION SERVICE INC**  
PO Box 1284  
Bridgehampton NY 11932  
631-404-2590  
beyer2buyer@gmail.com  
NYS Lic.# 160000512613

## **Confidential Inspection Report**

**123 Coconuts Dr.,  
Quackenbush NY**

**September 22, 2017**  
**(Inspection # 170999 ASHI # 261567)**

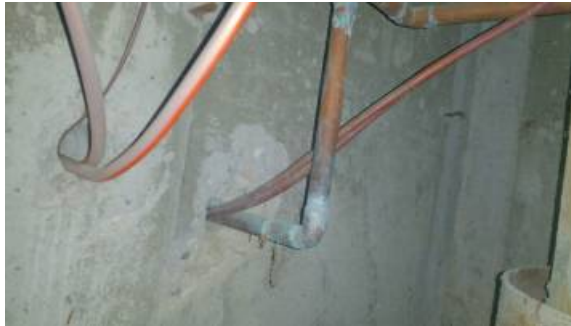
*Underground Fuel Tanks Noted:* Evidence noted is the presence of the old oil lines going through the wall to previous tank that was buried at right, where the family room now is. Owners stated they had their vacation of abandonment papers.

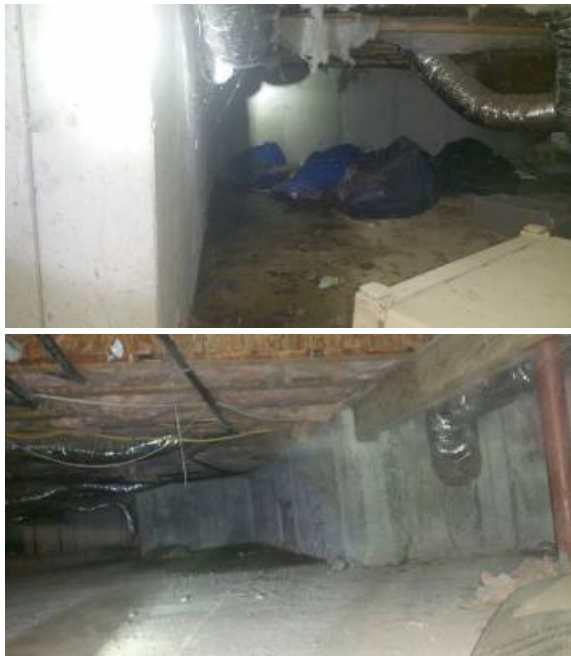
<i>Crawlspace Entrance:</i>	Satisfactory - The crawlspace entrance is adequately sized. At rear right. There is another opening under the rear deck that has no door. Animal entry possible.
-----------------------------	--

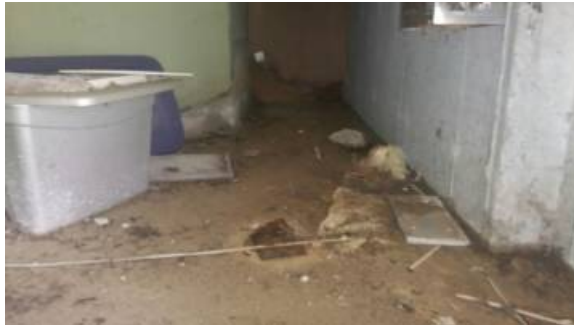
*Moisture on Exposed Crawlspace Walls Noted:* Yes - Higher than normal moisture levels were noted on the exposed areas of the interior crawlspace walls, and appear to be coming through the foundation vents. Easy fix. Some grading and a window well.

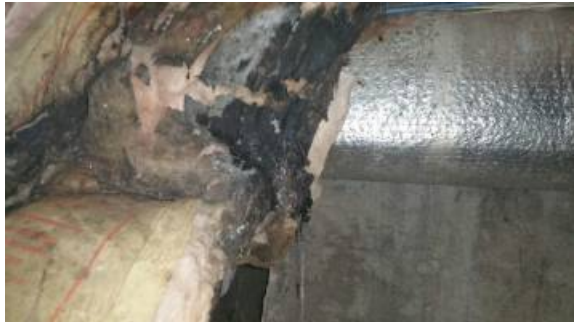
*Evidence of Mold Noted:* Only on wet piece of insulation that can be thrown away. Wet from the missing shower drain connection.

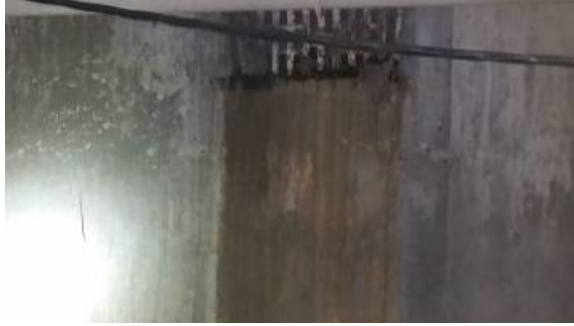
*Evidence of Water Entry in the crawlspace Noted:* There is evidence of water entry or damage in the crawlspace level. Some coming through a call space been. Repair as needed.

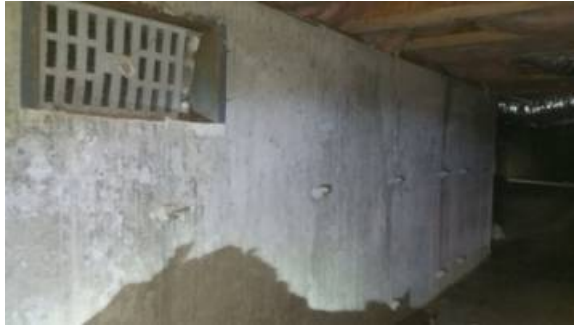
Satisfactory - The cross-ventilation in the crawlspace appears to be adequate. Some have missing screens. Replace as needed.

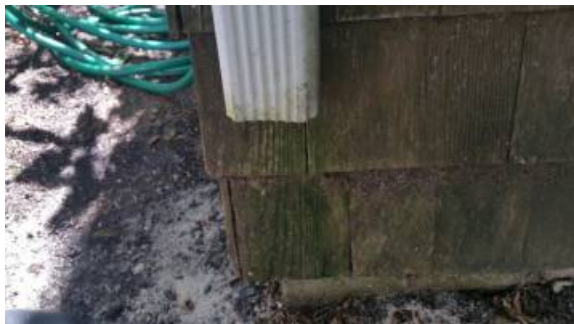
*Roof Gutter System:* The gutter system on the roof edge appears to be functional and adequately sloped to carry the water to the downspouts. The downspouts go into an underground system. I was unable to determine where they empty and if they are functional. Elbow and downspout missing at rear.

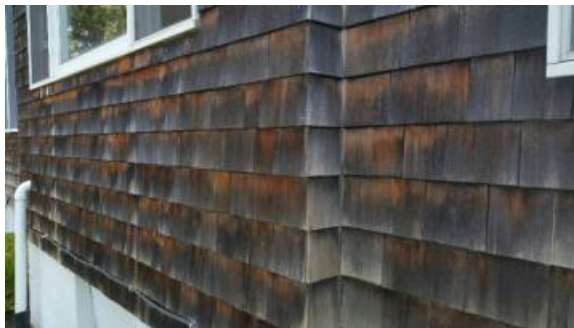
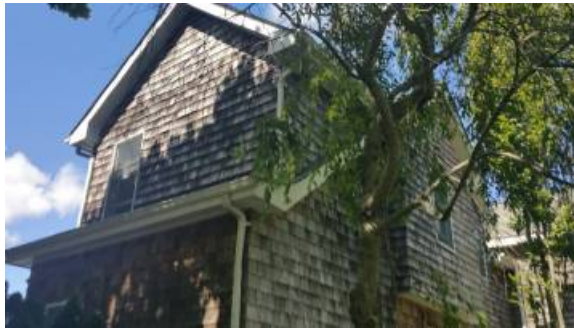
Satisfactory - The siding is in serviceable condition. Minor repairs where some shingles are loose and cracked. Typical with age and area.

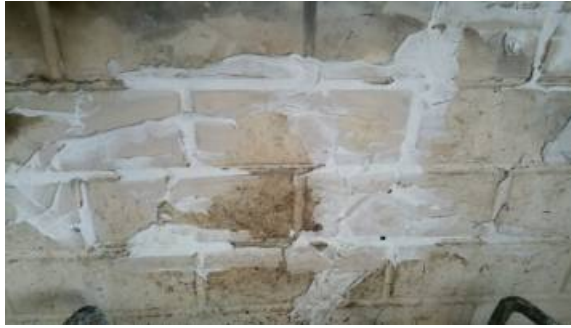
<i>Location of Fireplace:</i>	Living room.
<i>Type of Fireplace:</i>	Zero Clearance pre - fab type- There is a zero clearance fireplace installed. It is a metal double or triple walled unit that allows installation within inches of flammable materials rather than the standard 36 inch clearance on standard free standing metal fireplaces.
<i>Fireplace Fuel:</i>	Wood - The fireplace is designed to burn wood.
<i>Firebox Condition:</i>	There is a set of glass doors installed. Used correctly, these will help minimize heat loss when the fireplace is not in use. They also eliminate burning embers from flying into the room during a fire and reduce the volume of room air sucked up the chimney. Noted repair attempts. Firewall has been repaired. Check with homeowner for history.

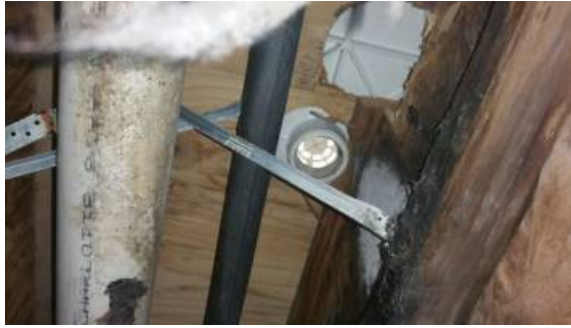
*Waste Piping Condition:* There is evidence of a leak in the drain/waste piping system. Services of a qualified licensed plumber may be needed. Drain pipe is not connected to base of shower at left down bath. Requires further review by a qualified plumber.

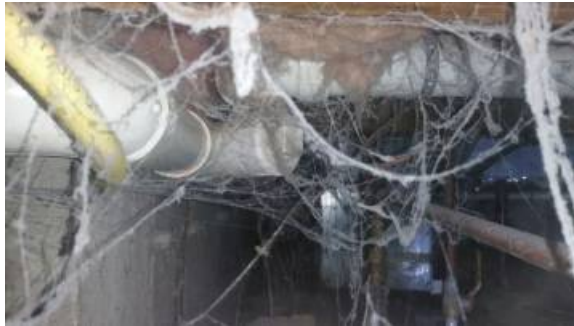
Intact in attic, and now in crawl. Was loose before, and allowed lint buildup. Reconnected now. Clean up lint.

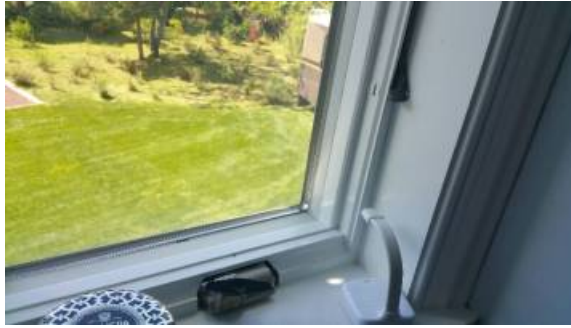
Satisfactory - The windows and associated hardware in the bathroom are all satisfactory. Missing hardware. Notes electric casements.

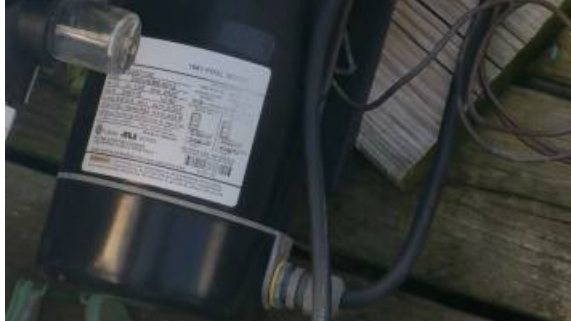
2012. 1 HP. Not grounded.

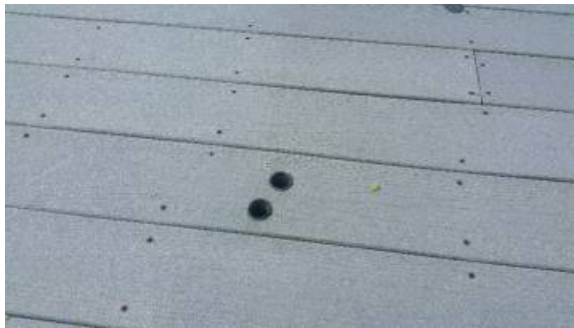
Holes in the deck indicate a child fence was installed in the past. Make inquiry with the seller about the whereabouts of any fencing materials.
