**BEYER : BUYER**  
**HOME INSPECTION SERVICE INC**  
PO Box 1284  
Bridgehampton NY 11932  
631-404-2590  
beyer2buyer@gmail.com  
NYS Lic.# 160000512613

## **Confidential Inspection Report**

**123 Coconuts Dr.,  
Quackenbush NY**

**September 22, 2017**  
**(Inspection # 170999 ASHI # 261567)**

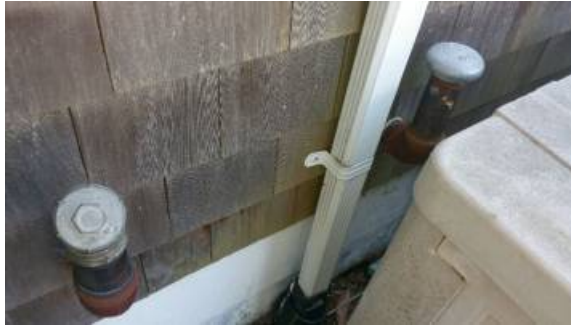
*Underground Fuel Tanks Noted:* Evidence noted is the presence of the old oil lines going through the wall to previous tank that was buried at right, where the family room now is. Owners stated they had their vacation of abandonment papers.

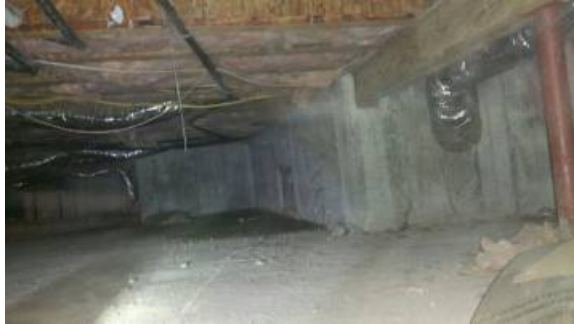
*Conditions Noted in Exterior Walls, Interior View:* Satisfactory - The exposed portions of the interior foundation perimeter walls appear to be satisfactory.

*Moisture on Exposed Crawlspace Walls Noted:* Yes - Higher than normal moisture levels were noted on the exposed areas of the interior crawlspace walls, and appear to be coming through the foundation vents. Easy fix. Some grading and a window well.

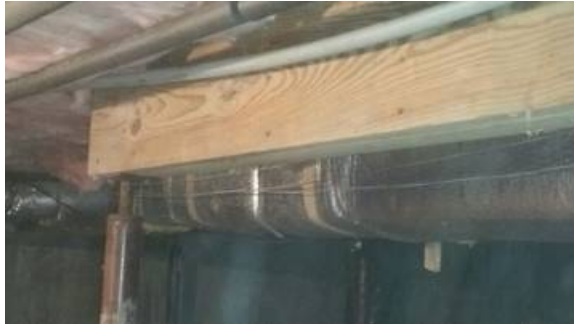
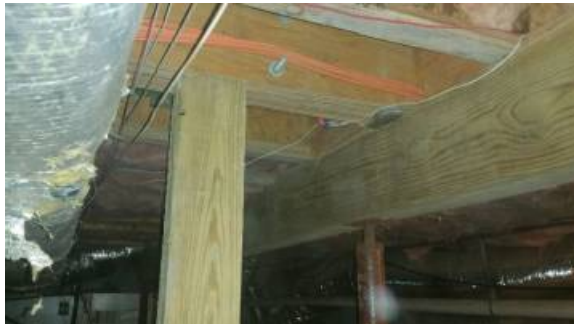
The 6 x 10" main beam is a single large dimension wood board.  
The 6 x 10" main beam is intact. Noted support upgrades.

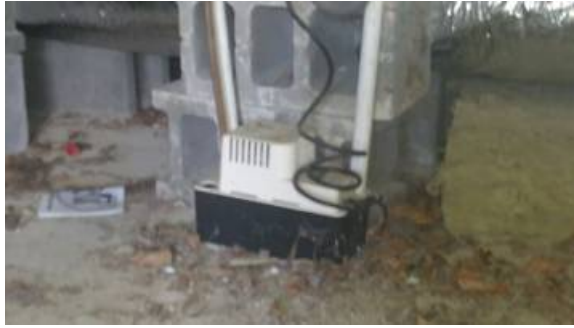
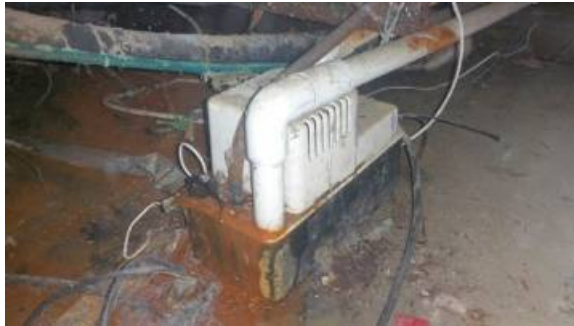
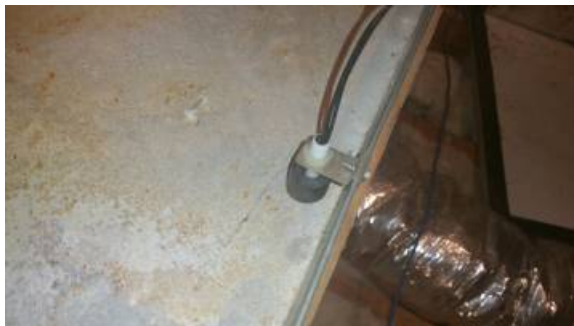
There is a condensate pump installed to remove the water from the furnace cabinet. Not operable. Wasn't plugged in, but didn't go on when plugged in. Requires further review by a qualified HVAC contractor. Water on floor.

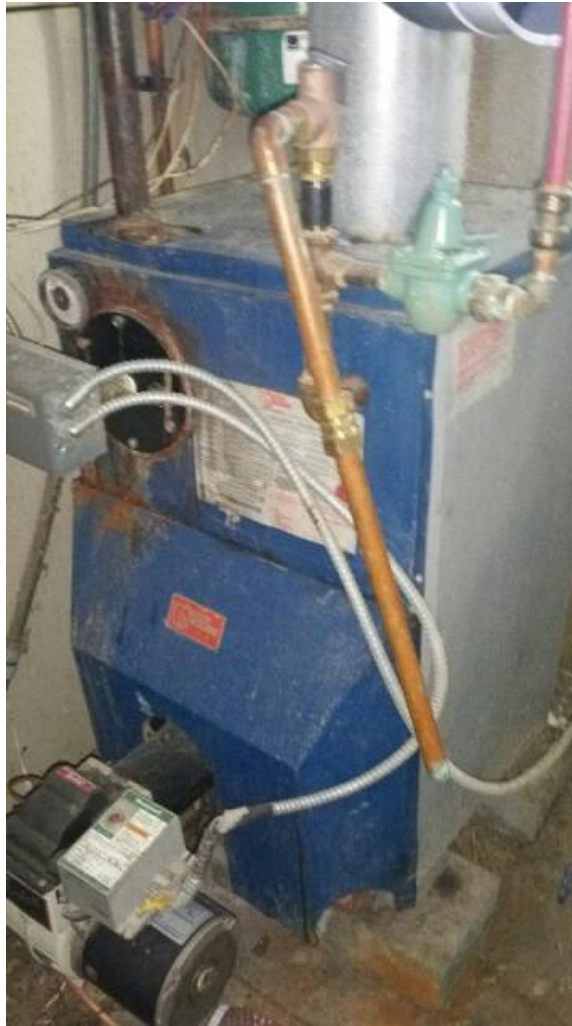
As a rule, steel boilers do not have the life expectancy of cast iron boilers. Check with the service company for a complete evaluation.  
Mid efficiency furnace, System is a Utica, steel hot water boiler.

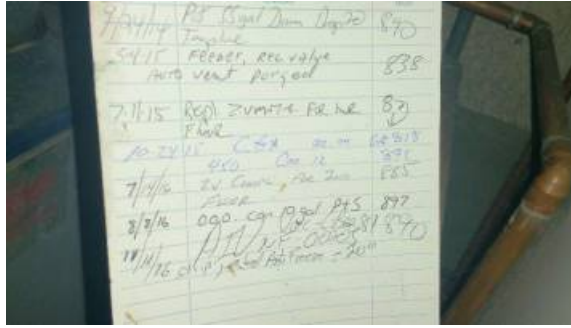
Unit was operational at the time of inspection. General condition appears serviceable. Last service was 11-11-16 by Petro. We suggest continued, routine service, safety checks (clean test and adjustment if necessary) to ensure appliance is operating at or near its maximum efficiency, and if there is a malfunction, it may be detected and properly corrected. Since boiler interiors are not part of this inspection, we advise having the service company check/verify this device for proper performance and integrity. We also suggest contacting the service company for any pertinent service information and history. Yearly scheduled service checks are advised for longer life.

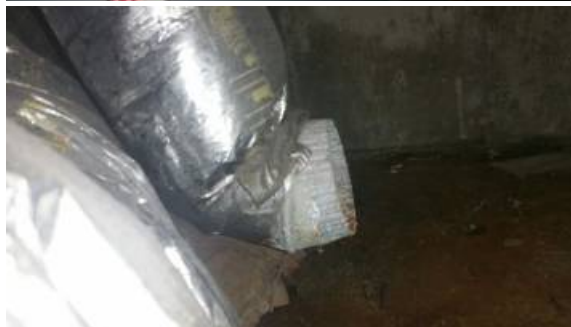
Disconnected ducting.

Not connected.

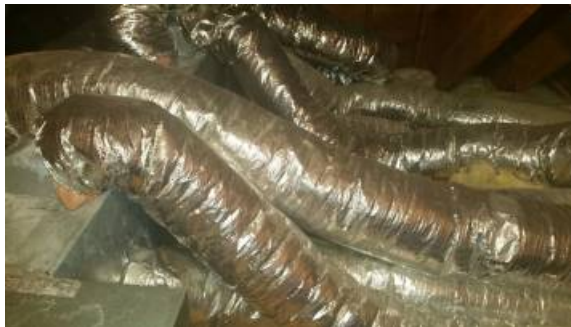
Exposed ductwork in unheated spaces is insulated adding to the efficiency of the heating and air conditioning systems.

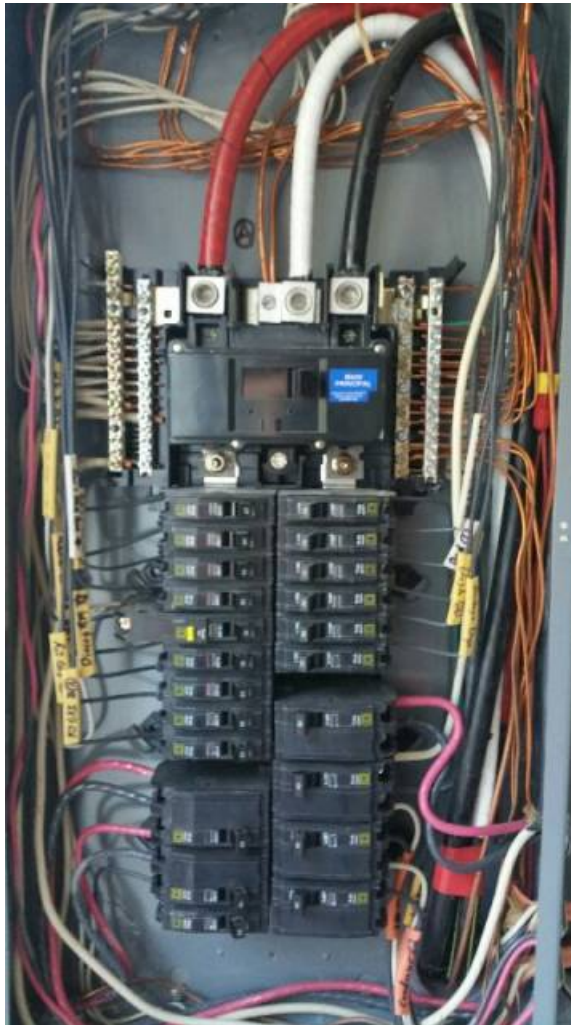
*Panel Cover Removed:*

Yes.

300 amp. 2 panels.

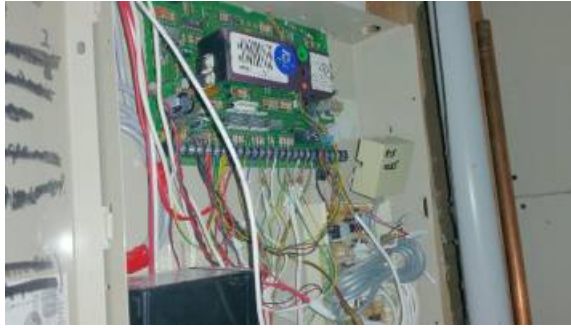
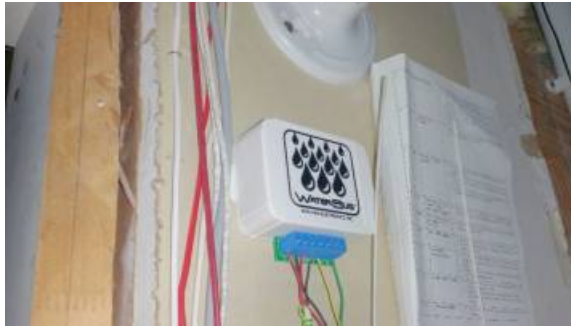
Water sensing device.

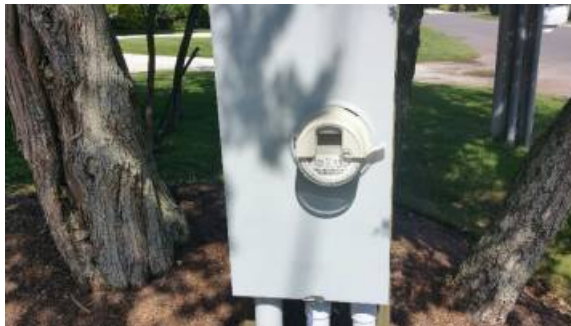
Satisfactory - The underground service appears adequate.

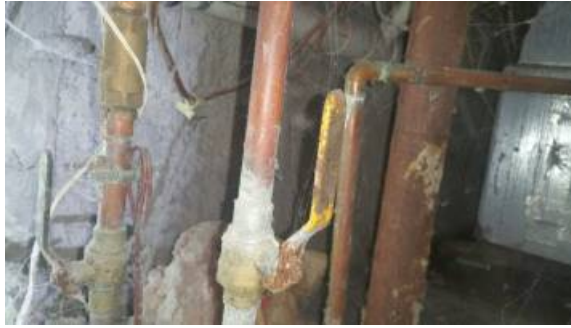
*Main Water Line Cutoff Location:*

In the crawl, front right corner.

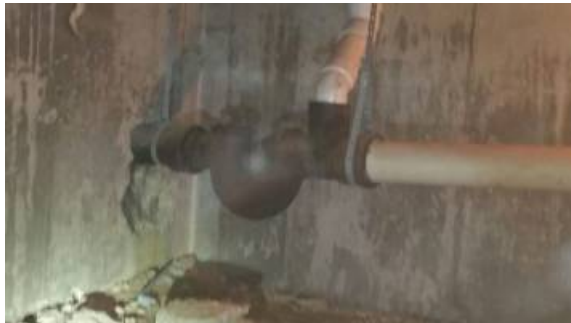
*Waste Line Materials* The predominant waste line material is plastic PVC to cast iron, out the front left.

*Waste Piping Condition:* There is evidence of a leak in the drain/waste piping system. Services of a qualified licensed plumber may be needed. Drain pipe is not connected to base of shower at left down bath. Requires further review by a qualified plumber.

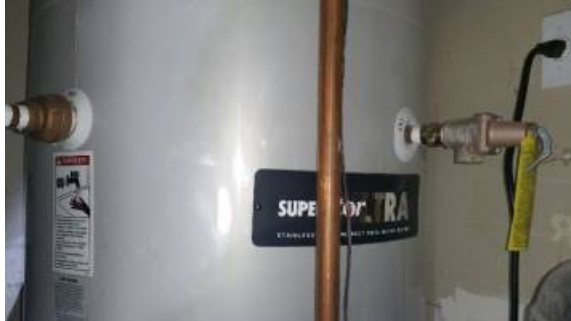
*Exposed Water Heater Condition:* Good - Rust free and clean. Should provide years of service.

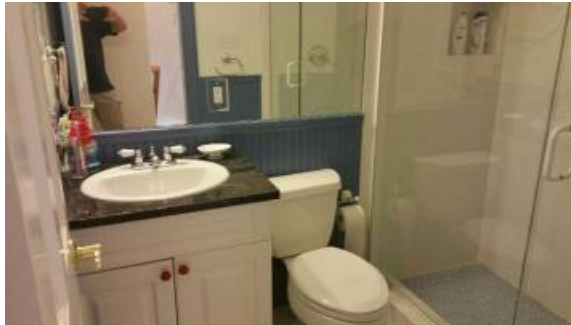
Satisfactory - The vanity cabinet and top in this bathroom are satisfactory. Right side.

The toilet is not secure to the floor, allowing it to wobble and possibly leak. Action should be taken to re-secure it to the floor.

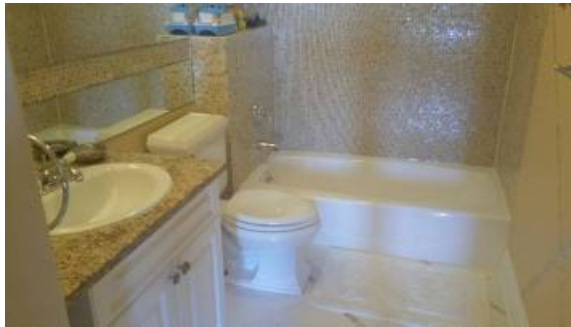
**Bathroom #3:**

*Vanity Cabinet:* Satisfactory - The vanity cabinet and top in this bathroom are satisfactory. Upper hall right.

*Toilet Condition* The toilet is not secure to the floor, allowing it to wobble and possibly leak. Action should be taken to re-secure it to the floor.

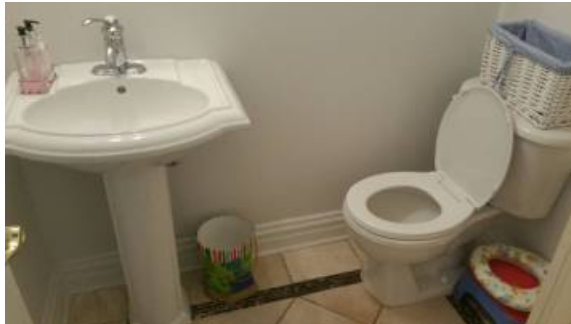
## Powder Room

*Vanity Cabinet:* None.

<i>Basin and Drain Fixture:</i>	Satisfactory - The basin and drainage fixture appears to be satisfactory. Pedestal.
<i>Faucet and Supply Lines:</i>	Satisfactory - Faucets and supply lines appear satisfactory. There are shutoffs installed for both hot and cold water pipes under the basin. Loose. Tighten.
<i>Toilet Condition</i>	Satisfactory - The toilet in the master bathroom appears to be functional.
<i>Heat Source:</i>	Satisfactory - There is a heat source in this room.
<i>Entry Door:</i>	Satisfactory - The entry door to the bathroom is as I expected, and it is functional.
<i>Walls:</i>	Satisfactory - The walls in this bathroom are satisfactory.
<i>Windows:</i>	None - There is no window in this bathroom.
<i>Ceiling:</i>	Satisfactory - The ceiling in this bathroom is satisfactory.
<i>Floor:</i>	Satisfactory - The flooring in this bathroom is satisfactory. The floor covering material is ceramic or glazed tile.

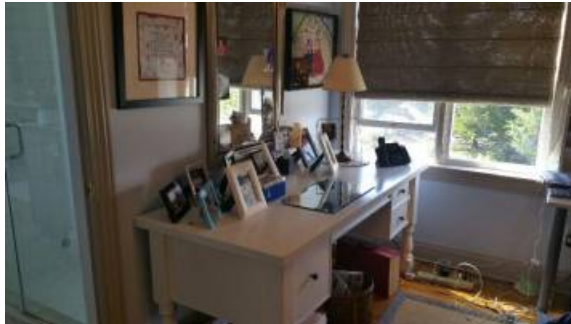
## Office/Bedroom

*Entry Door:* Satisfactory - The entry door is functional. Hall door doesn't latch.

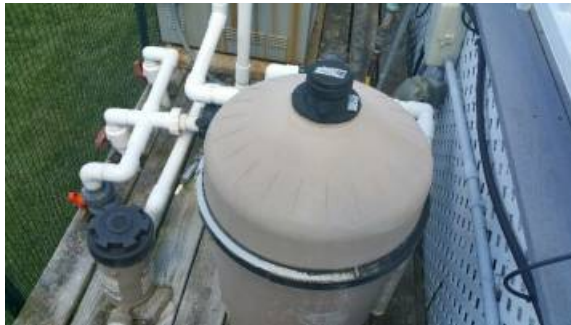
*Hair/Lint Filter:*

Diatomaceous earth. Hayward.

OK, 17 psi.
